Lost Beagle2 probe found 'intact' on Mars

16/01/2015

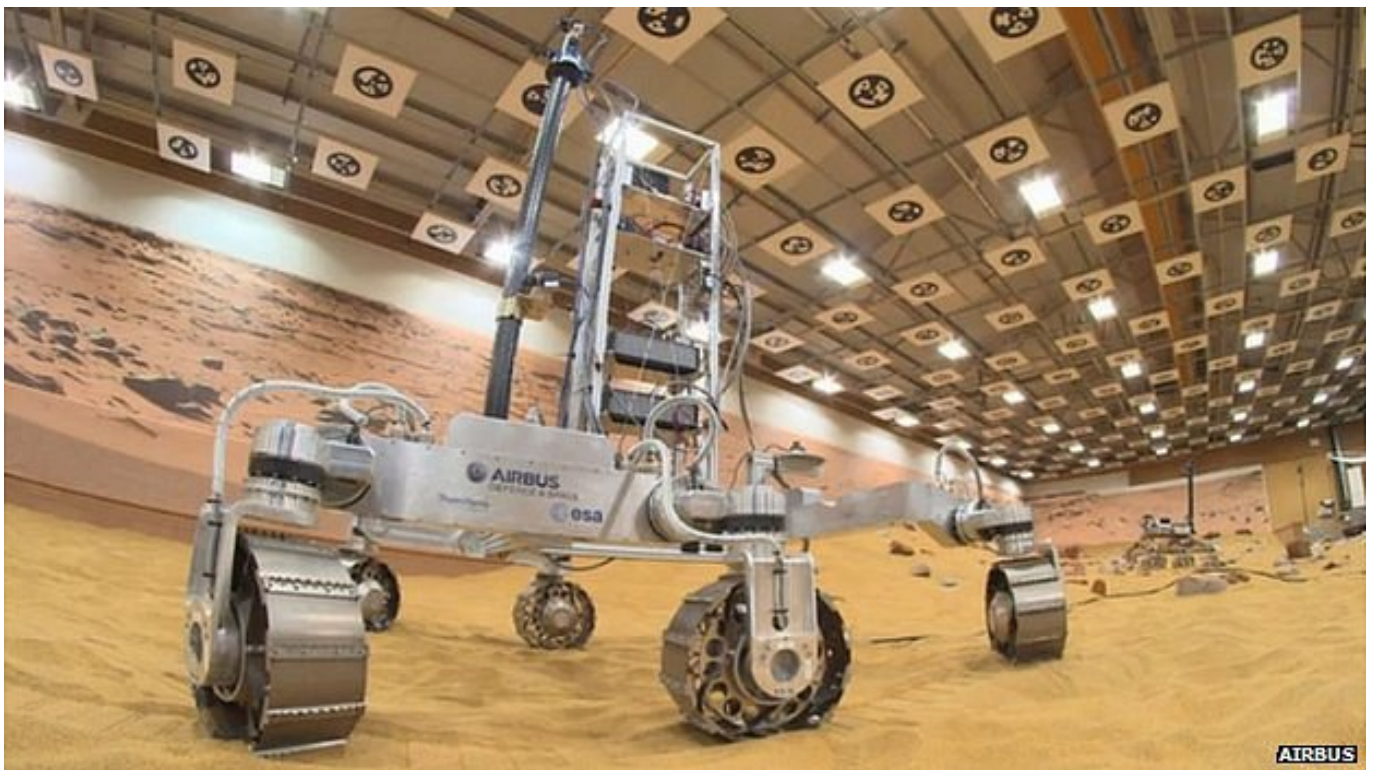
The ExoMars rover is currently in development with Airbus in the UK

When Esa's ExoMars rover tries to land on the surface of the Red Planet in 2019, it will be relaying information all the way down.

The landing hardware for this mission is being built by the Russians, but its key sensor technologies, such as the descent radar, are being developed in Europe and will be tested on a demonstration landing in late 2016.
