Lost Beagle2 probe found 'intact' on Mars

16/01/2015

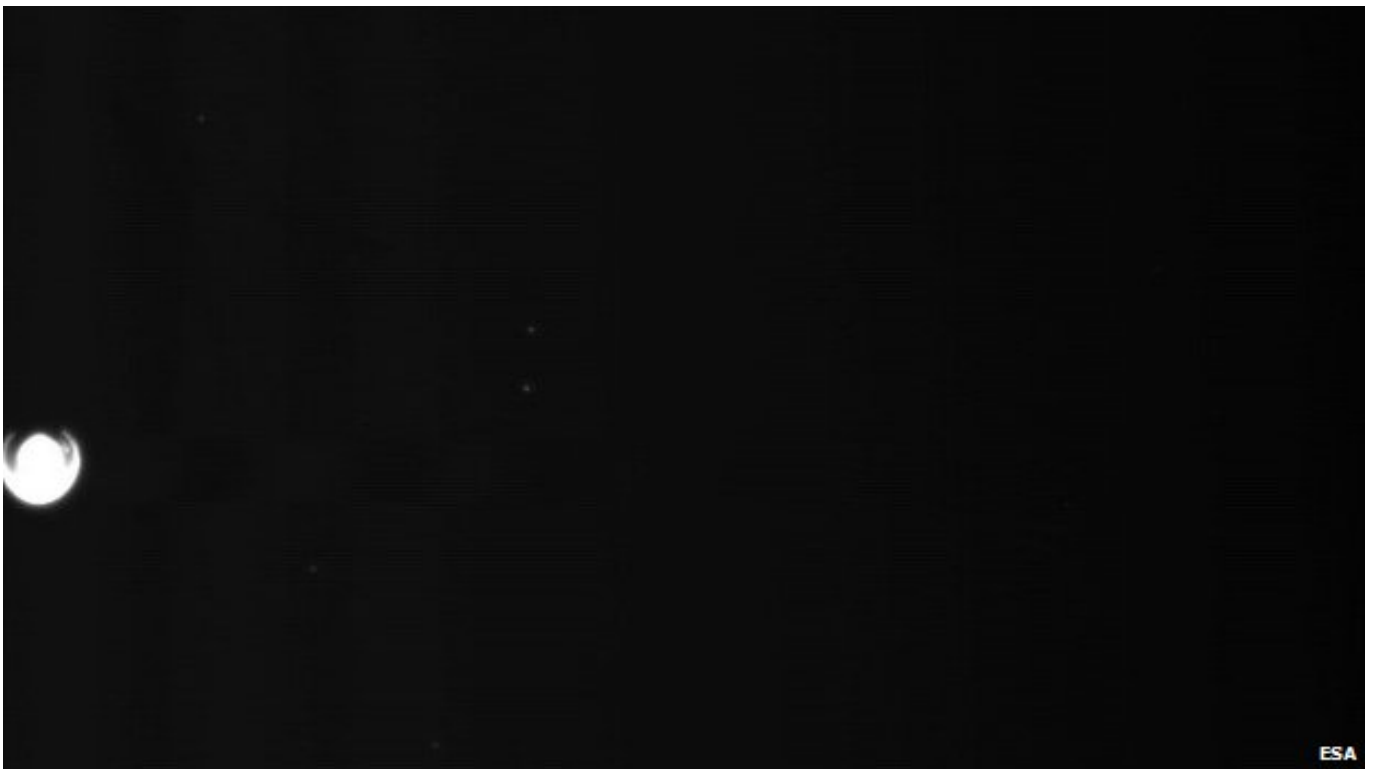
At far left, MEx snaps Beagle heading away towards Mars in its protective entry shell

MEx released the little robot on to its landing trajectory on 19 December 2003. It even snapped a picture of Beagle, in its entry capsule, receding into the distance. What followed was a mystery.

This has become standard practice in recent years, but with Beagle its last contact was essentially that black and white photo of it moving away from the MEx orbiter six days prior to landing.
